**Michael W. Hester, Cherokee Nitrogen, a subsidiary of LSB Industries, Inc., USA, and Daniel J. Benac, Baker Engineering and Risk Consultants, Inc., USA,** present an example of HTHA, including an HTHA failure in an ammonia plant, and provide mitigation actions to be taken to reduce the risk of future HTHA failures in other equipment and piping.

# REDUCING THE RISK OF HTHA FAILURES

## Plant case history

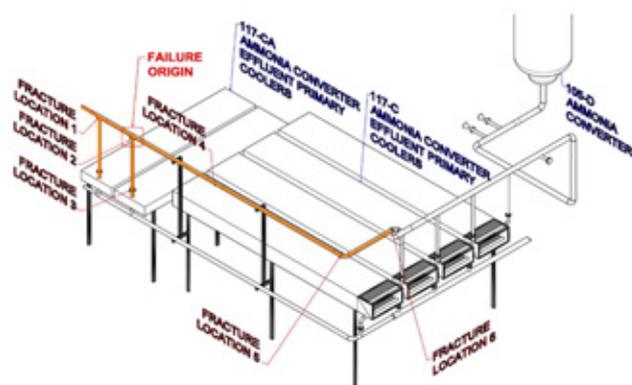
At the time of failure, it was unknown that a section of carbon steel piping was installed in the header of an auxiliary effluent cooler that was added to the primary cooler approximately 40 years prior to the incident (refer to 117-C and 117-CA in Figure 1). As a result, the carbon steel piping was operating above the recommendations for this material as identified in the 8<sup>th</sup> edition of the API RP 941 curve illustrated in Figure 3.

**Figure 1.** Location of the failure of the fracture in the 6 in. dia. carbon steel header.

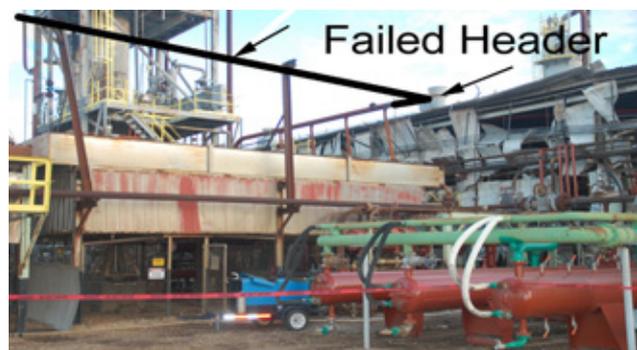
Approximately 5 years later, during a routine plant start-up on 13 November 2012 at 10 pm, the ammonia converter effluent cooler header piping suddenly ruptured. No fatalities or major injuries occurred, yet the rupture released hydrogen, resulting in a fire and equipment damage that caused plant downtime of approximately 6 months prior to equipment repairs and upgrades for restart. The schematic equipment layout and missing ruptured header are shown in Figure 1 and Figure 2 respectively.

**Figure 2.** The missing segment of the ruptured 6 in. dia. carbon steel header.

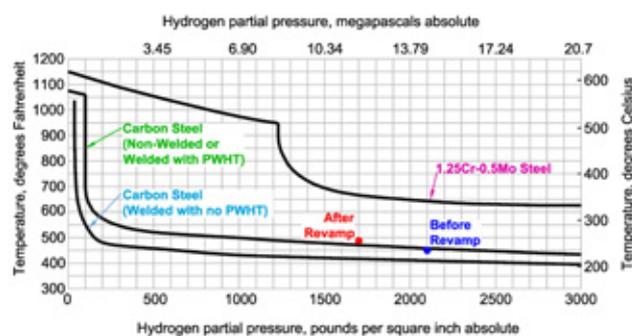
Based on the 7<sup>th</sup> edition of the 941 curve for carbon steel, the piping was slightly below the curve prior to the converter revamp. However, after the revamp in 2007 the piping was now operating above the carbon steel curve. As now known from the

new 8<sup>th</sup> edition released in 2016, the previously identified carbon steel curve in the 7<sup>th</sup> edition reflects the welded condition with post-weld heat treatment (PWHT).<sup>2</sup> As noted in Figure 3, welded carbon steel piping without PWHT would have been operating above the curve before and after revamp of the converter.

**Figure 3.** Illustration showing the before and after revamp operating conditions compared to the API RP 941.

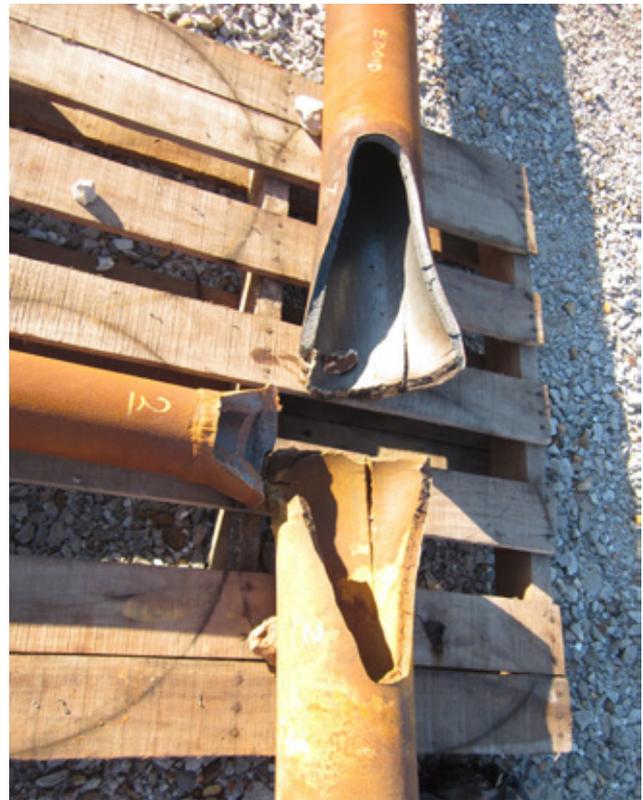
The investigation into the effluent cooler header piping rupture determined that the header, shown in Figure 4, had a brittle fracture appearance and failed due to HTHA. Figure 5 shows the microstructure and evidence of HTHA degradation that occurred in the header after 5 years of operation at the revised operating pressures and temperatures.

**Figure 4.** The brittle fracture of the header due to HTHA.

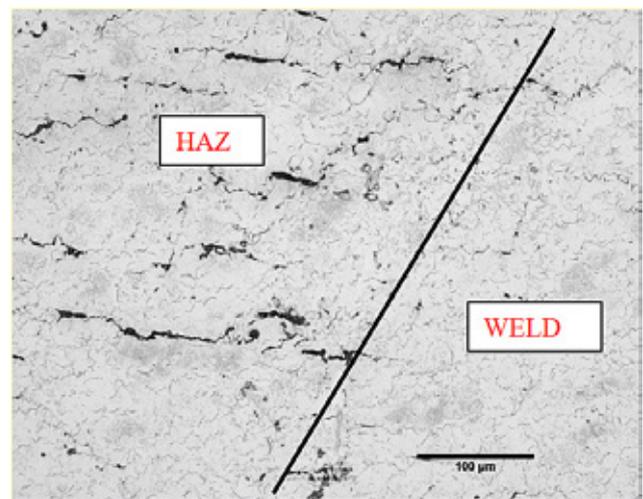
Under the influence of certain temperature conditions and hydrogen partial pressure, atomic hydrogen permeates the steel and reduces iron carbide ( $\text{Fe}_3\text{C}$ ) in the steel to form methane ( $\text{CH}_4$ ). This process causes decarburisation to occur in the steel. The methane does not diffuse from the metal so its pressure may build and exceed the cohesive strength of the metal, causing fissuring between grains, blisters, and cracks. When fissuring occurs, as shown in Figure 5, the ductility of the metal is significantly and permanently reduced.

**Figure 5.** Hydrogen damage observed in the carbon steel line at the heat affected zone (HAZ). Decarburisation and fissuring region caused by hydrogen depleting the iron carbides. (Original magnification: 200x).

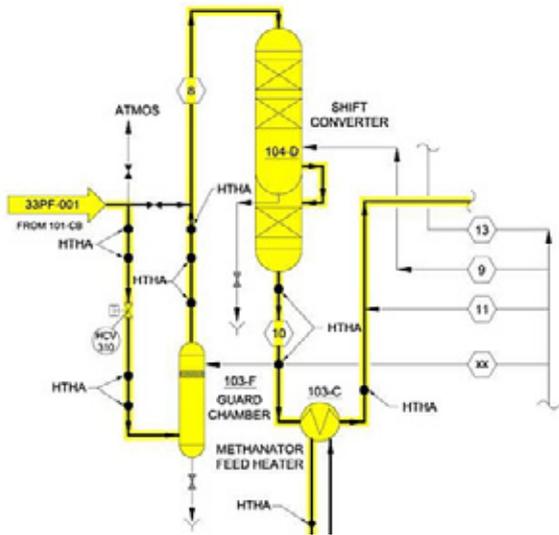
Figure 6, Figure 7, and Figure 8 show potential HTHA risk sites for ammonia plant equipment constructed from vintage design specifications utilising carbon steel or other alloys susceptible to HTHA attack.

**Figure 6.** Likely HTHA locations near the high temperature shift converter.

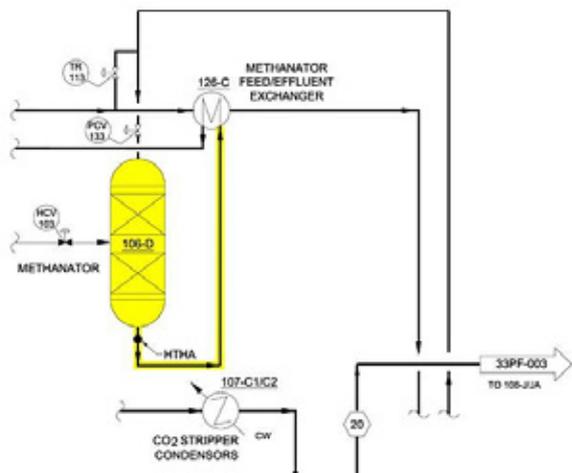
**Figure 7.** Likely HTHA locations near the methanator.

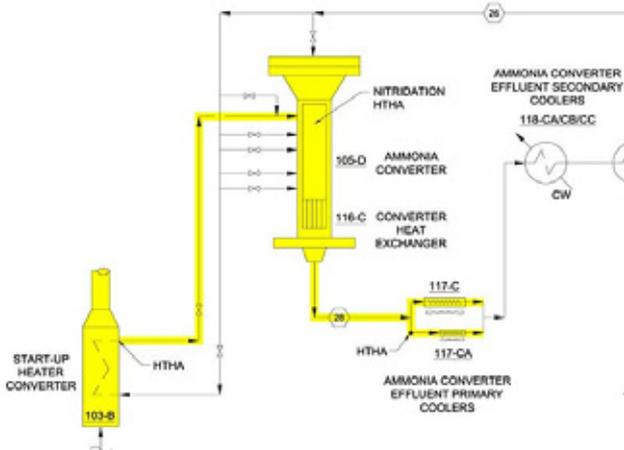
**Figure 8.** Likely HTHA locations near the ammonia converter.
